**The MacFarlan House:
A Survey of an Okie-Designed Work in Progress**

Rebecca Angeline Geist

Historic Preservation

1998

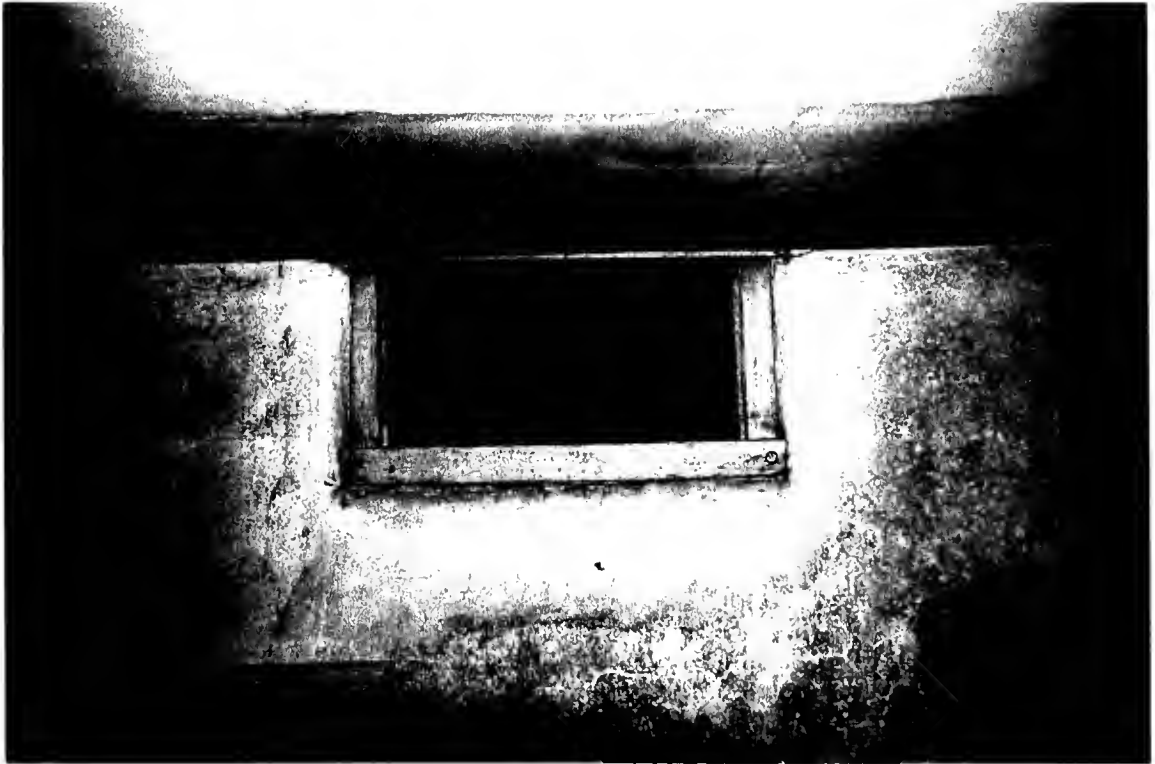
Figure 2.1d The lower half of an exterior window is located in the attic wall between the eastern and western portions. Before the western portion was added, this window was facing outside. The roof collars, with attached ceiling, are now placed in front of the opening on the west side, though the window is fully apparent from the eastern section.

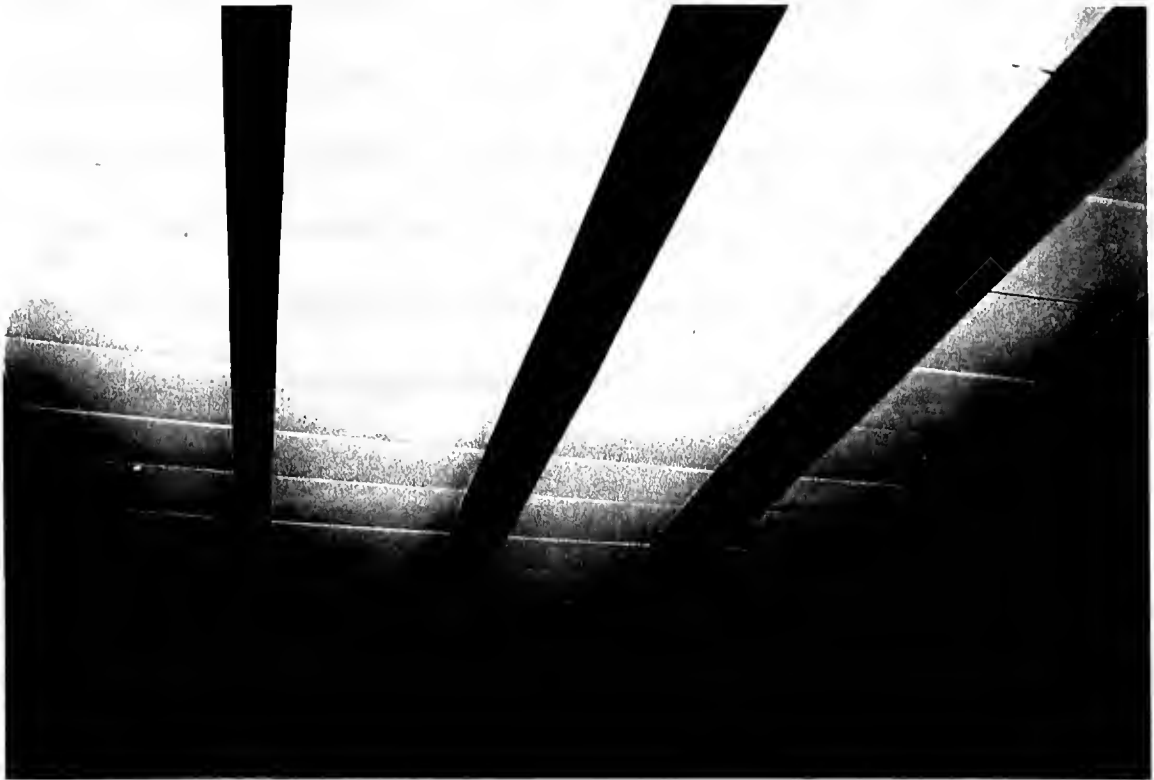
Figure 2.2b The Mr. and Mrs. Al Tegler House near West Chester, an R. Brognard Okie "restoration" from 1926-1931, for Samuel Eckert retains its beaded, exposed joists. These joists were once covered with lath and plaster which was subsequently removed for restoration.

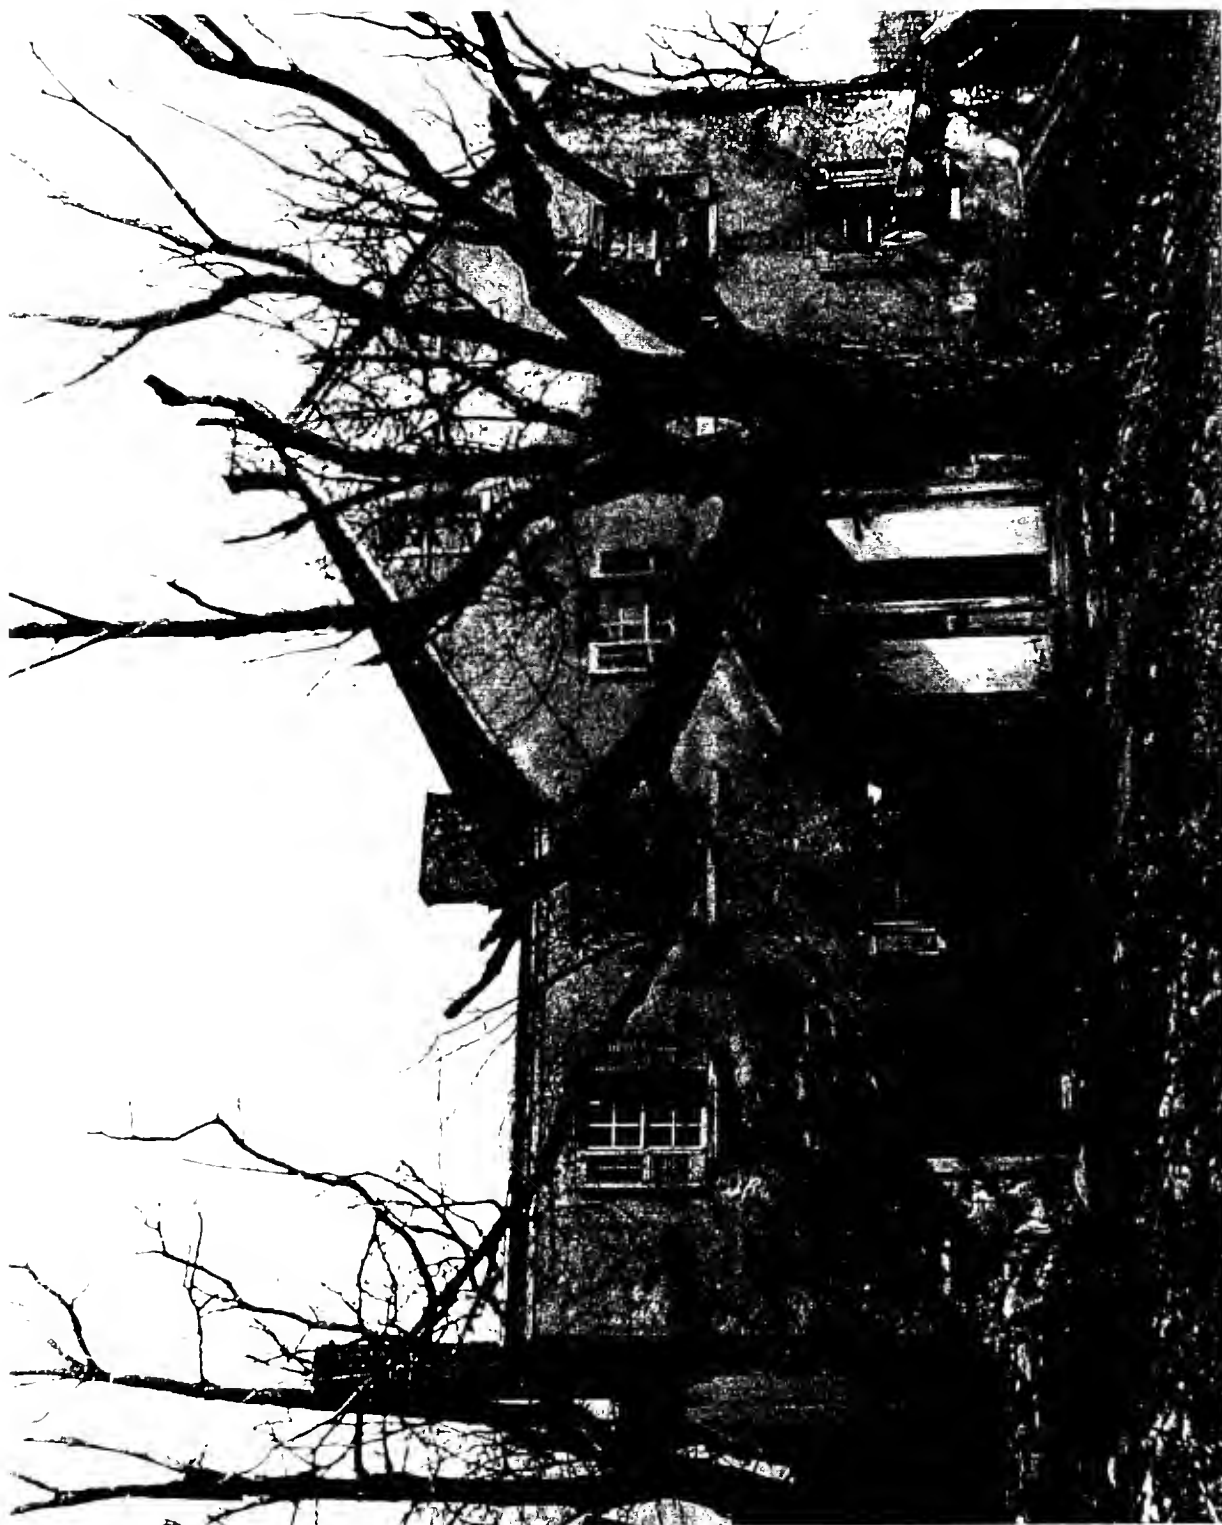
Figure 2.5a. Photograph of house's west elevation before construction by Colonel MacFarlan, circa 1937. A sloping shed roof is apparent over the northern section (to the left). The outline and stone ruins of a former room remains on northern end.

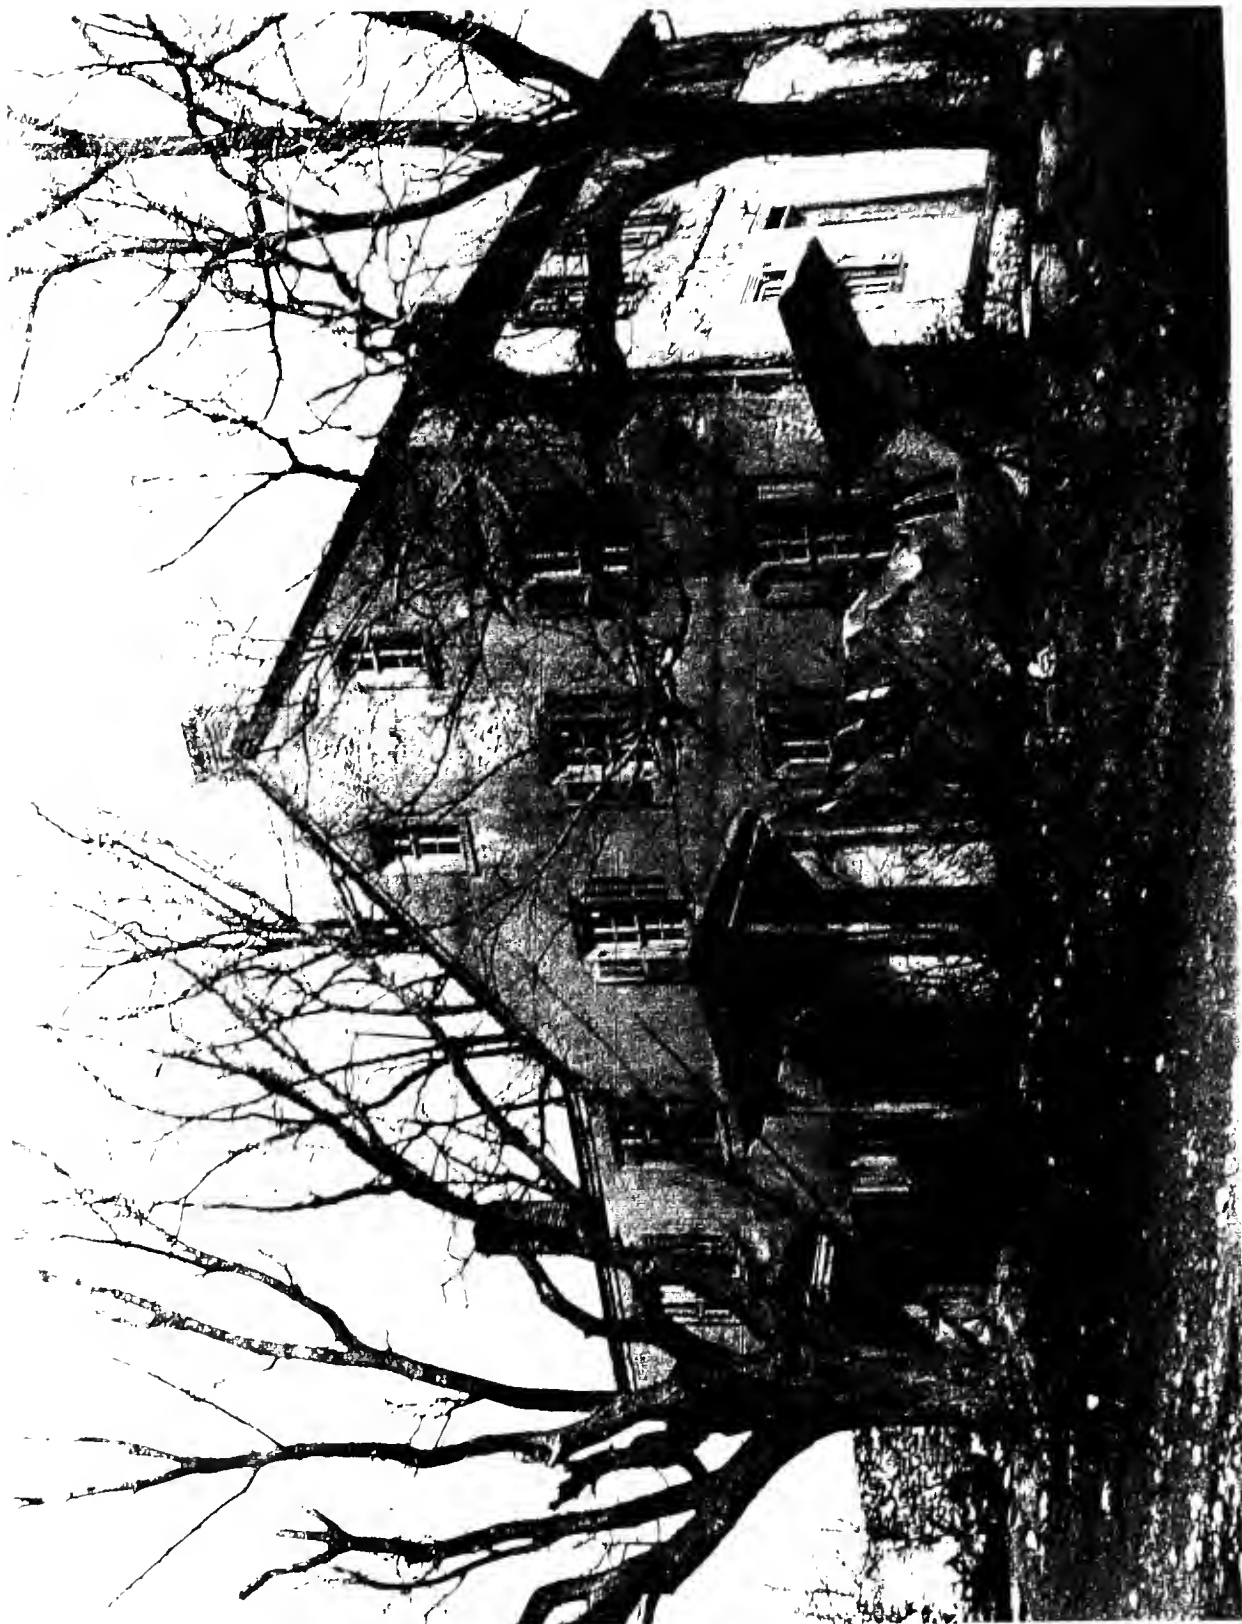
Figure 2.5b. Photograph of house's west and south elevations before construction by Colonel MacFarlan, circa 1937. Porch brackets of side porch are of Victorian period. Stone wall ruins indicate a former room to the north.

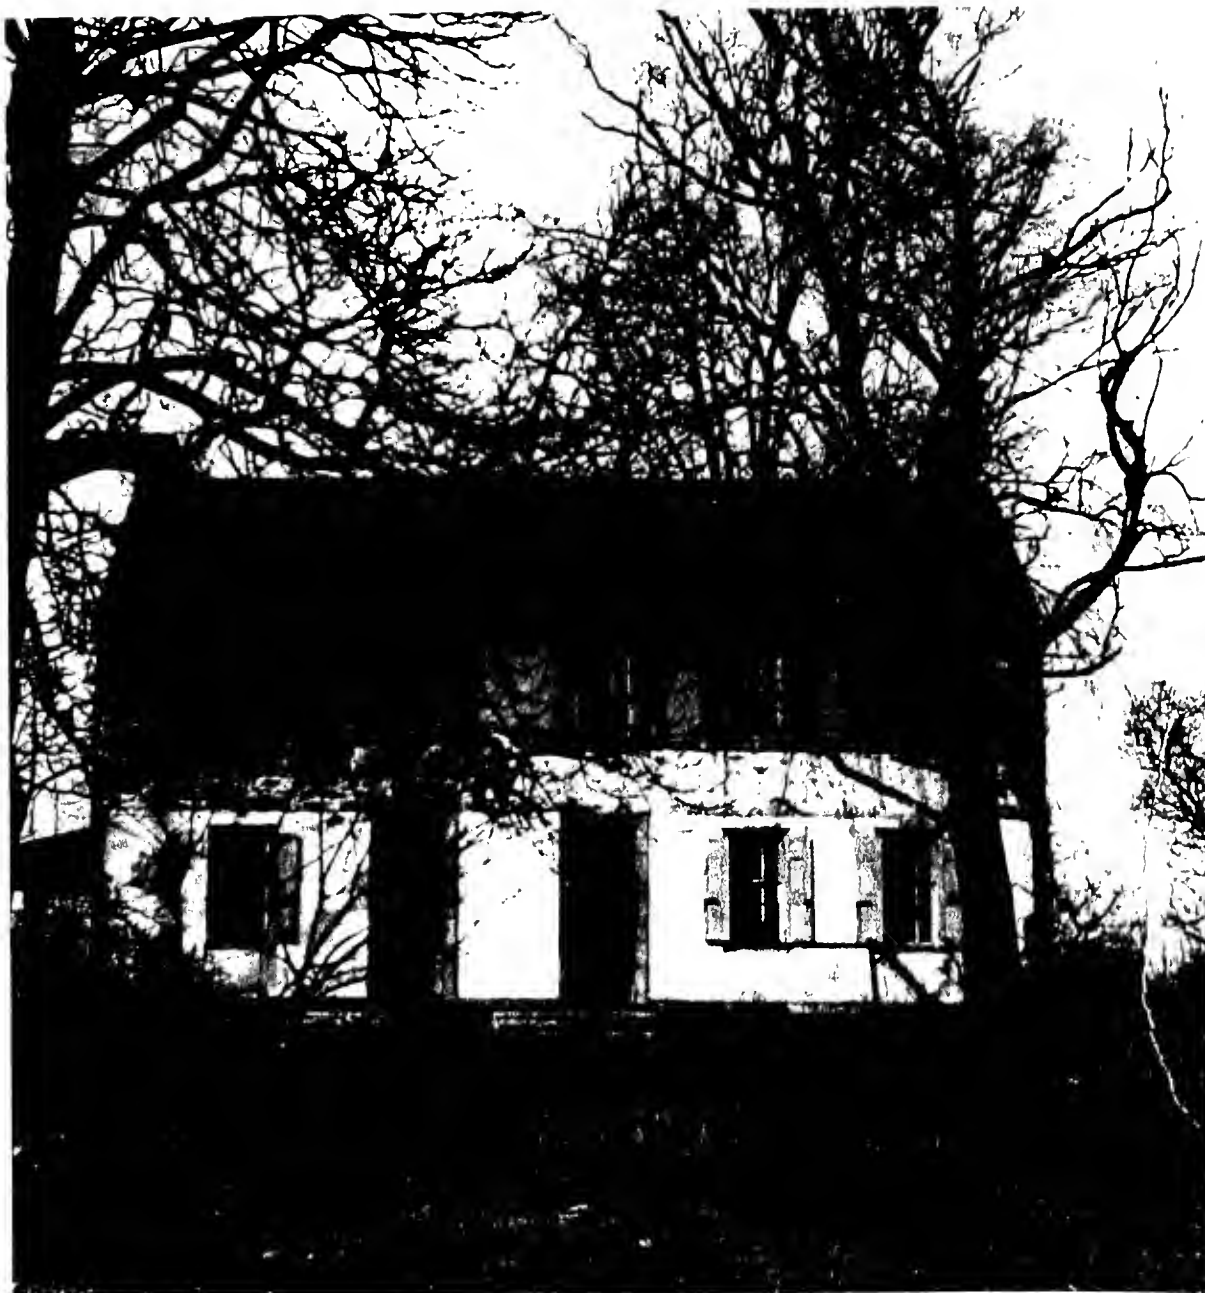
Figure 2.5c. Colonel MacFarlan photographed the house's south elevation as it appeared before construction began, circa 1937. This is the "front" of the house, facing Buck Road, with North Buck Road to its left side. The front shows the five bay form, with the second door from the left leading into the "central hall." The windows on the lower floors are six over nine, while those above are six over six.. The facade reveals where two separate pent roofs were once attached. At some point, likely during the Victorian period, these were removed and a large porch was added across the front, missing by the time this photograph was taken. The metal roof was also likely a Victorian addition, replacing wooden shingles.

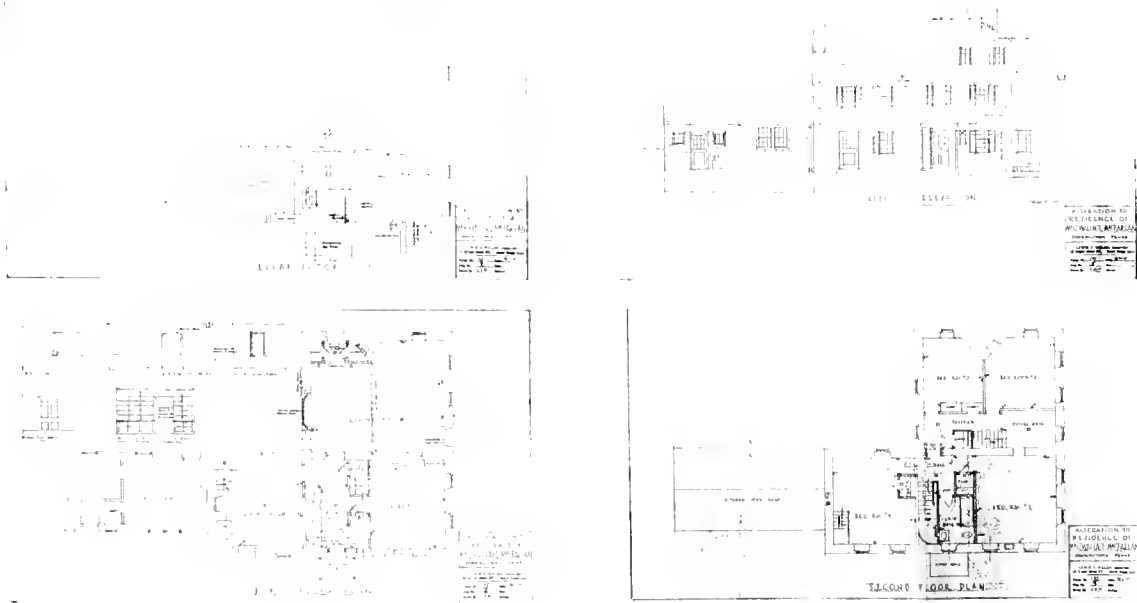
Figure 2.6 This is a sampling of Lewis E. Welch's floor plans and elevations for the MacFarlan House, circa 1937

chose to retain the center hall stairs and the partition wall between the two rooms of the eastern section, though dotted lines are drawn to "show future...walls." He even retained the corner cabinet, only traces of which can be found today, in the new western hallway, and used it to conceal the new soil pipes from the bathroom above. Both bedrooms in the eastern section of the house were retained in near-original state, with the bedroom in the eastern section enlarged and similar to Welsh's design. Two new passages on the second floor were created, one through the stone partition wall of the eastern and western sections at the foot of the stair and one to the new bedroom over the current dining room. Brumbaugh also changed the landing of the steps in this bedroom over the dining room from a 180° turn to a 90° turn at the midpoint, with the rest of the stairs at a straight run. These stairs were original to the third building campaign when this section had a shed roof. Because the roof on the rear portion of the room was now raised, the stair could afford to not land in the center of the room for head height.

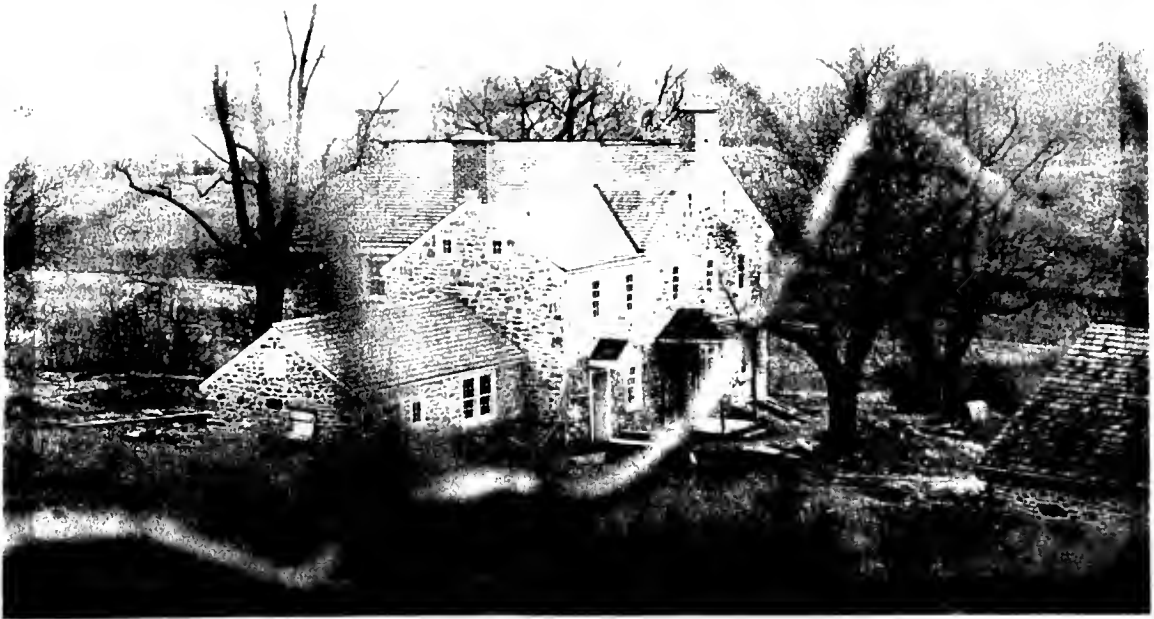
Figure 2.8a Photograph taken by the Colonel sometime during either Lewis E. Welsh's or G. Edwin Brumbaugh's construction period. This shows the new kitchen wing and the raised shed roof to a full gable roof over the present dining room area, exact date unknown.

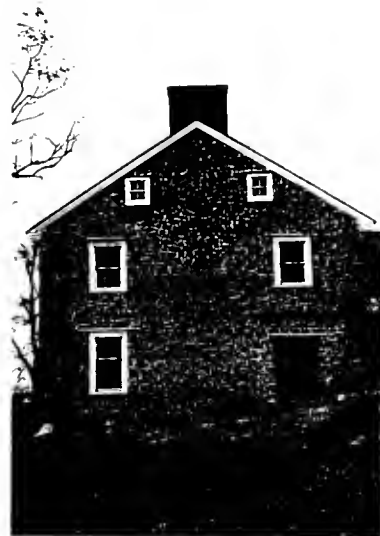
Figure 2.8b Photograph taken by the Colonel sometime during or after G. Edwin Brumbaugh's construction period. This photo is the only one of a series taken to show the eastern elevation. Notice the original stone lintels over the windows. The placement of a nailer over the door indicates where Brumbaugh's design called for the "future porch" in his plans, exact date unknown.

Colonel MacFarlan photographed the house at one stage of construction, likely that of Brumbaugh's date because of the porch design and the hood over the dining room door, but much of this exterior may have been completed during Welsh's period, with Brumbaugh concentrating more on the building's interior spaces (Fig. 2.8a). There is also one photograph of the east side of the house, likely taken during Brumbaugh's period, showing a wooden beam ready to support the "future" porch. This is referred to in Brumbaugh's First Floor Plan (Fig. 2.8b).

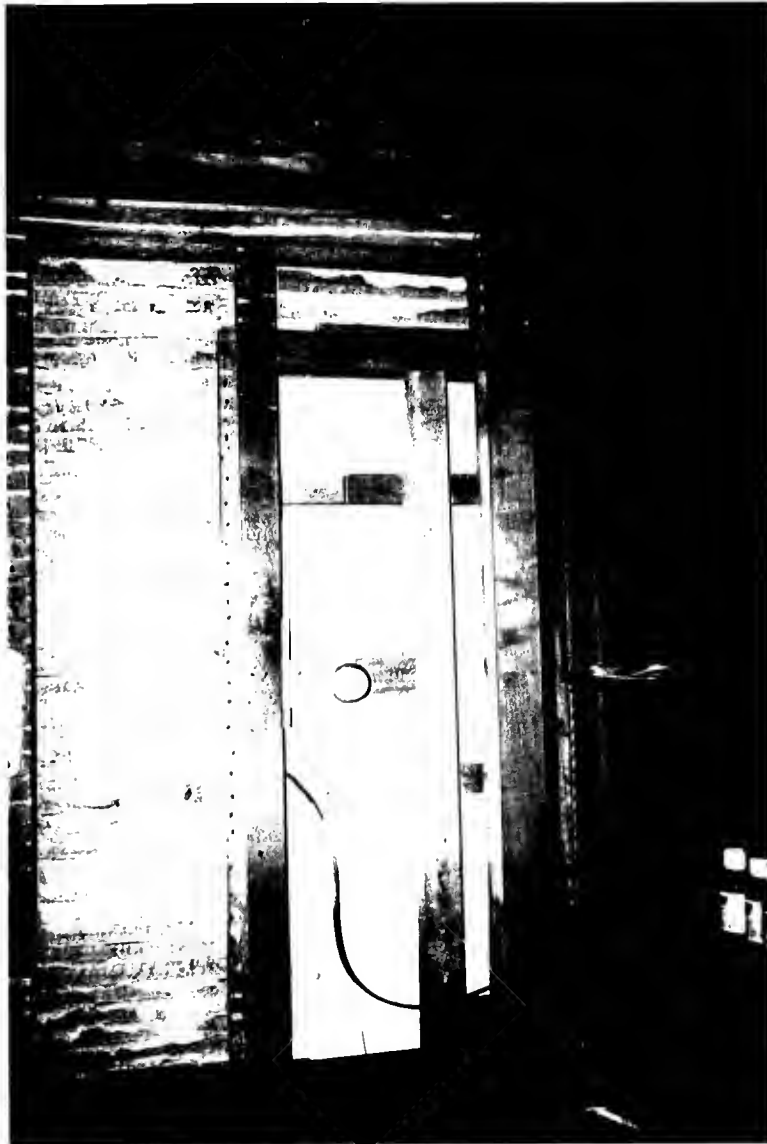
Figure 2.9b This is the partition wall between the two rooms of the ground floor, eastern section of the house. Here, framing for a once-existing door is apparent, covered on the opposing side with feather board. At the top of the photograph, the end of what were the exposed, beaded joists in the existing library can be seen. These joists were subsequently covered with lath and plaster during the construction campaign in which the renovation and addition of the western section of the house occurred. This photograph was taken in the study, south wall.

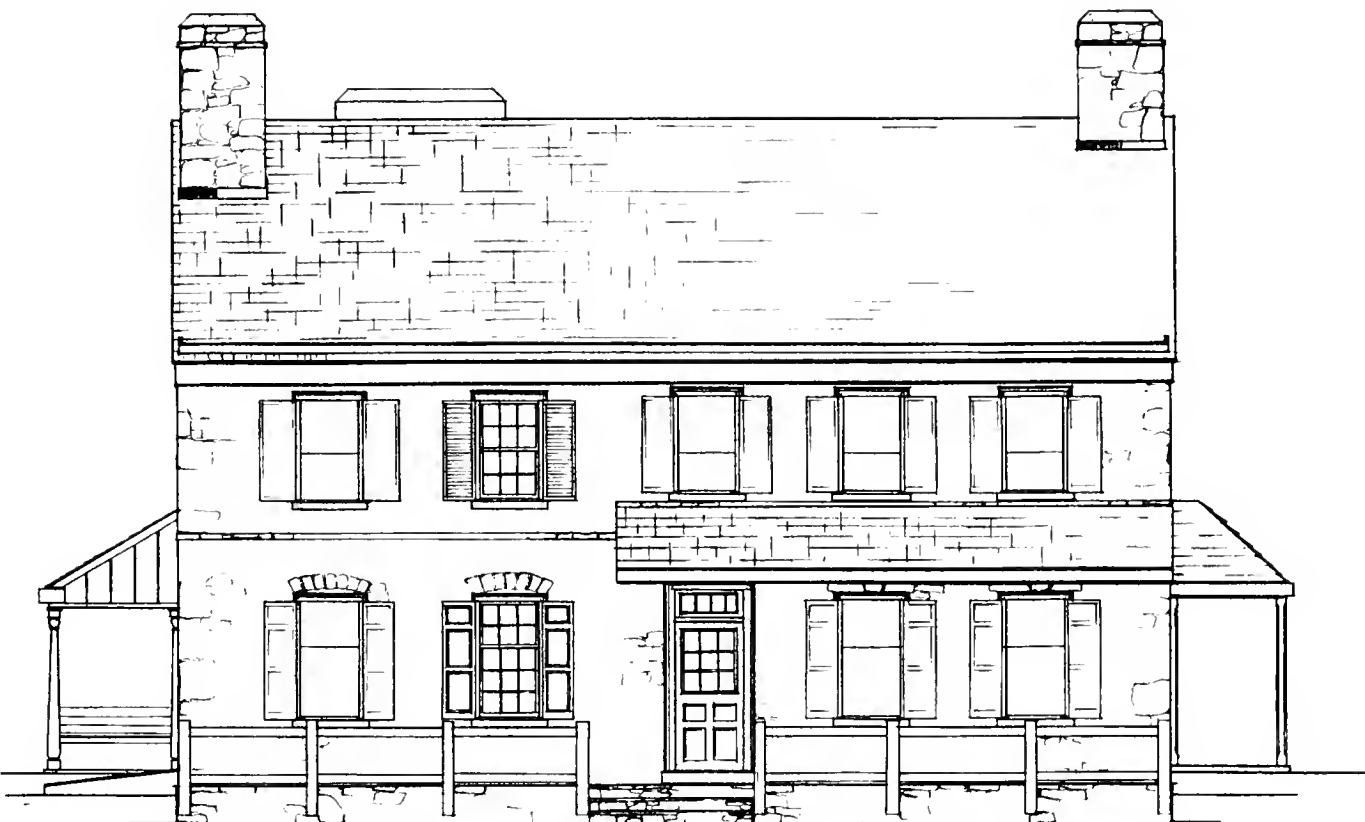
South Elevation

Figure 2.11a MacFarlan House south elevation (reflects design by R. Brognard Okie, existing conditions measured and drawn by author).

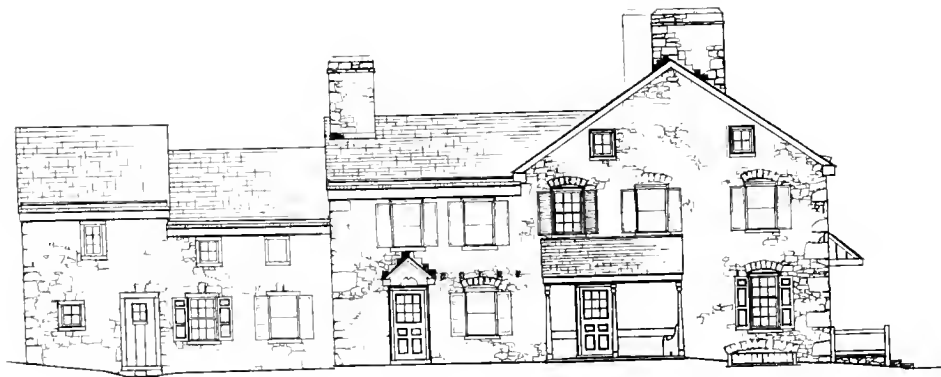
West Elevation

Figure 2.11b MacFarlan House west elevation (reflects design by R. Brognard Oke, existing conditions measured and drawn by author).

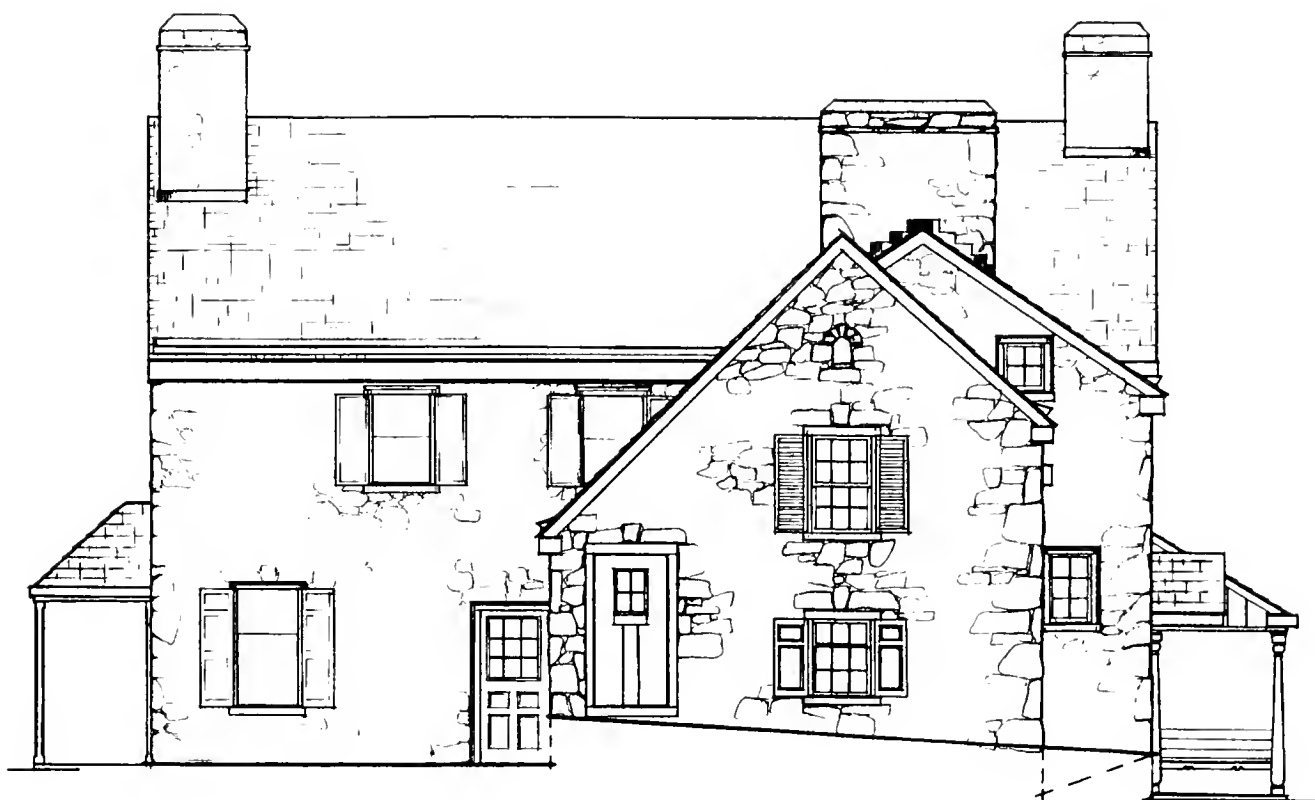
North Elevation

Figure 2.11c MacFarlan House north elevation (reflects design by R. Brognard Okie, existing conditions measured and drawn by author).

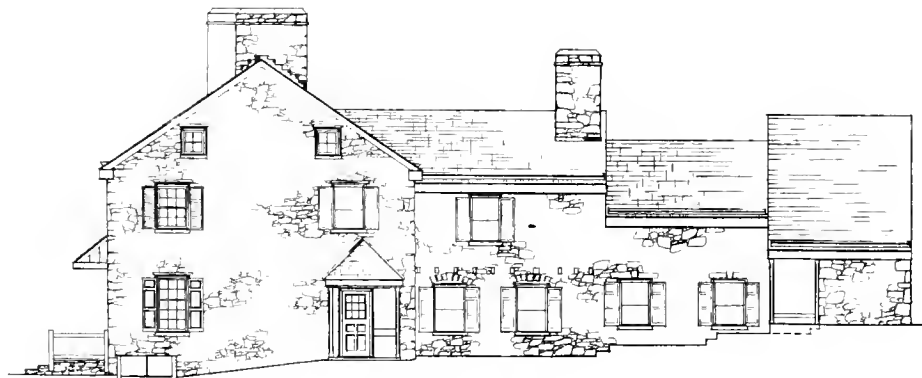
East Elevation

Figure 2.11d MacFarlan House east elevation (reflects design by R. Brognard Okie, existing conditions measured and drawn by author)

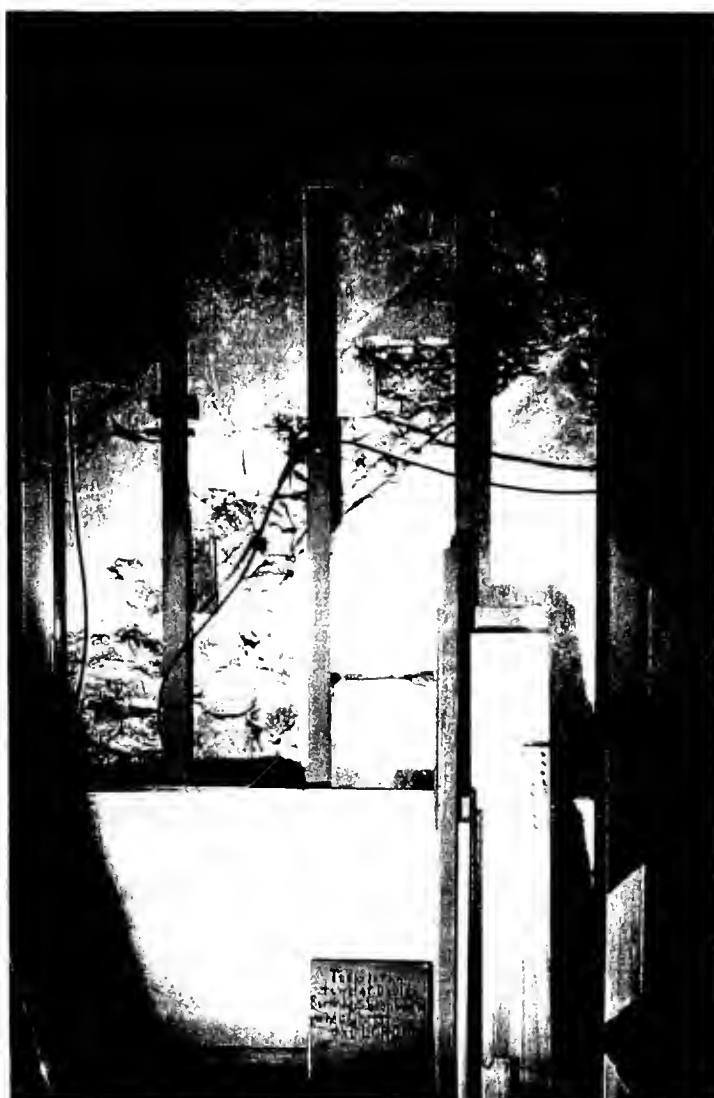
Figure 3.1 This photograph shows the layers of the various building campaigns which occurred with the MacFarlan House. Remnants of a previous staircase (added in the third building campaign), old lath and plaster, an I-beam, brick in-fill, furring strips, and Okie-designed horizontal beaded board wainscoting can be seen. The door frames in the foreground are of Brumbaugh's design and construction period.

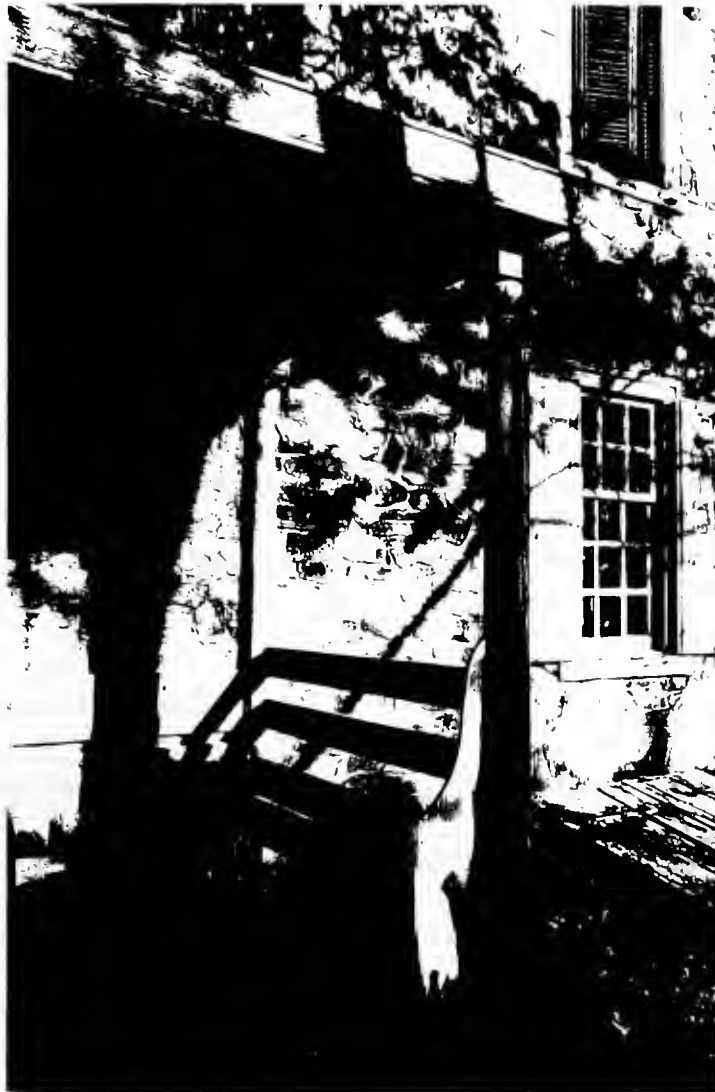
Figure 3.6e This photograph is of the detailed bench with the key hole-shaped cut out at the bottom and the "scallop" detail above the seat.

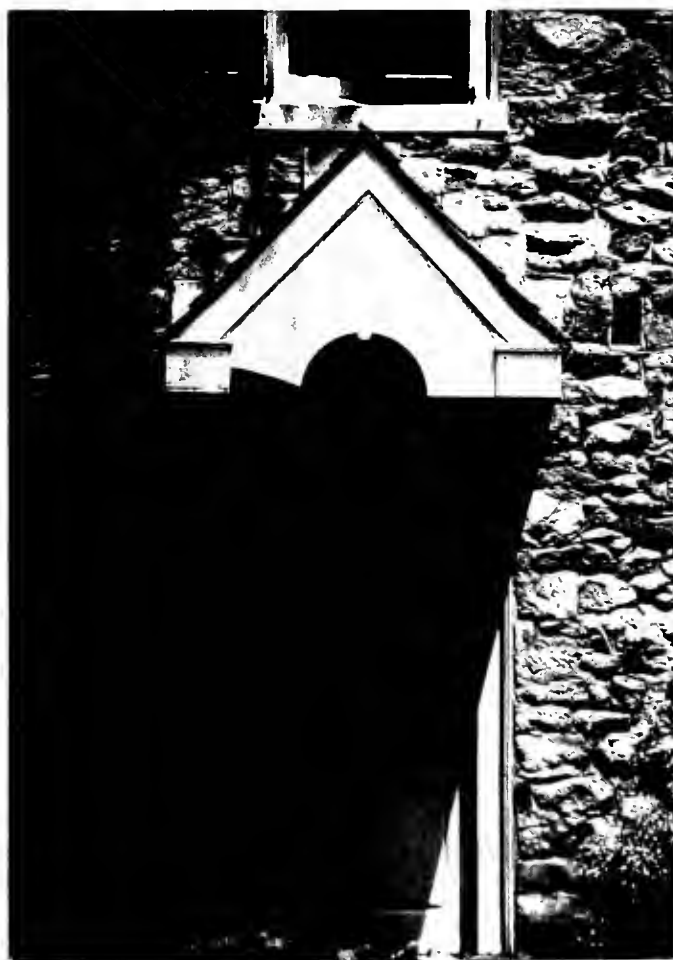
Figure 3.7b Photograph of the door hood above the dining room door.

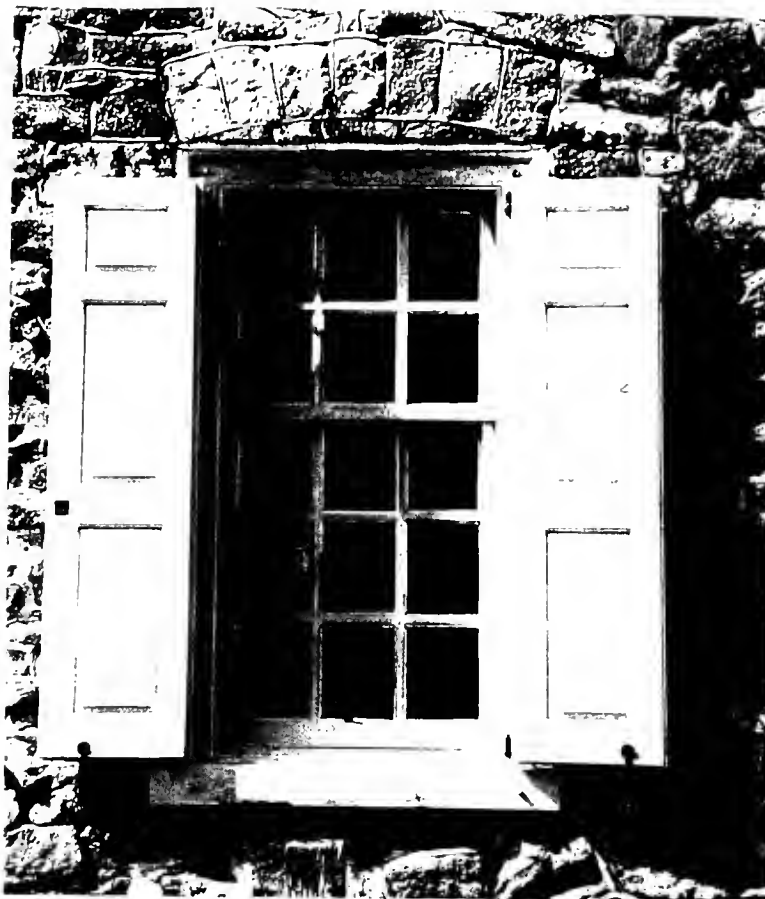
Figure 3.9a and 3.9b
Two types of shutters on the exterior of the MacFarlan house. The first type is paneled when open, but a single board when closed. The second type are louvered.

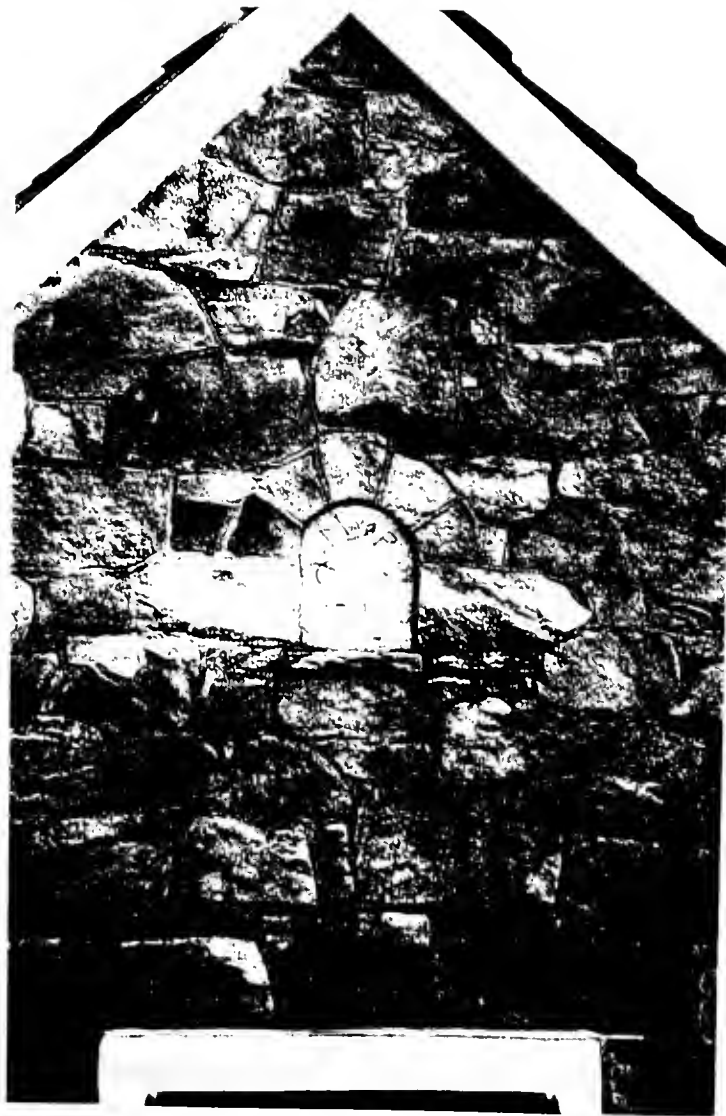
Figure 3.11 Okie often inserted date stones bearing the initials of his clients and the date of construction of the building. This date stone reads, "MacF C W 1942," for Charles Wallace MacFarlan, built in the year 1942.

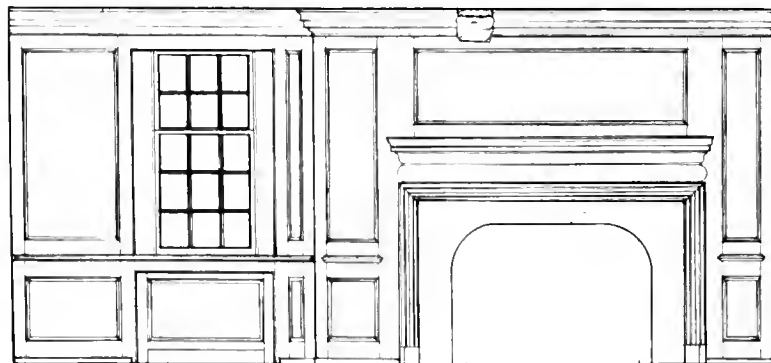
Figure 3.12b Living Room West Elevation. Oke designed a traditional paneled fireplace wall for this elevation. The radiator cover under the window is designed to blend with the raised panel motif of the walls.

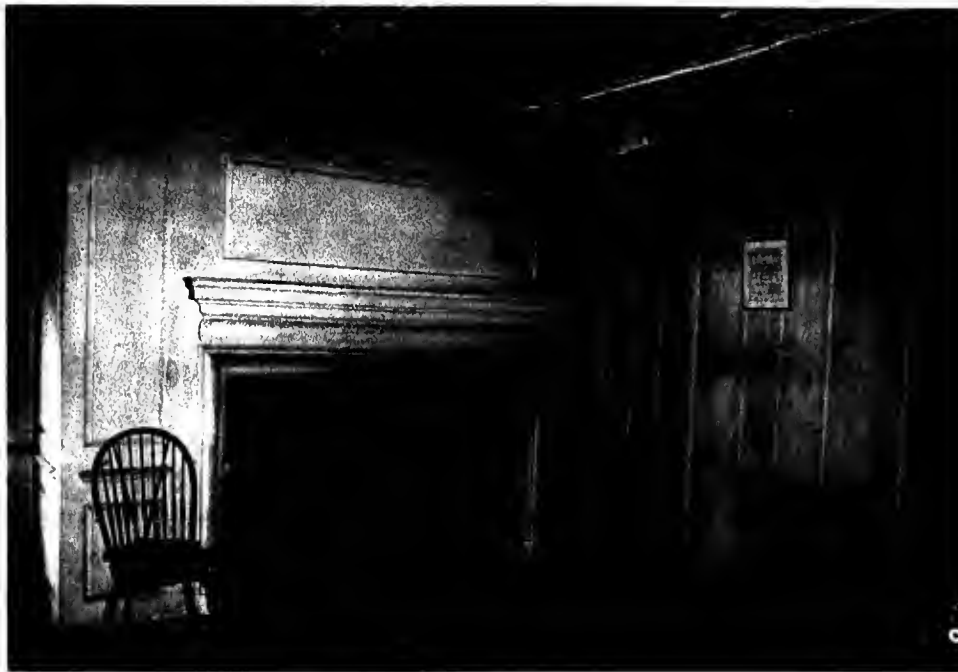
Figure 3.12c Photograph of the west elevation fireplace wall showing the corbelled stone protruding through the raised panel above the mantel to support the summer beam.

Consultation of these drawings shows the living room was built much as indicated, though minor differences between the drawings and the as-built conditions occur. The location of the summer beam dividing the room was not shown in Okie's design scheme and appears to be an afterthought. The beam is supported by a corbelled stone from the chimney above the mantel and disrupts the cornice along the west wall (Fig. 3.12c).

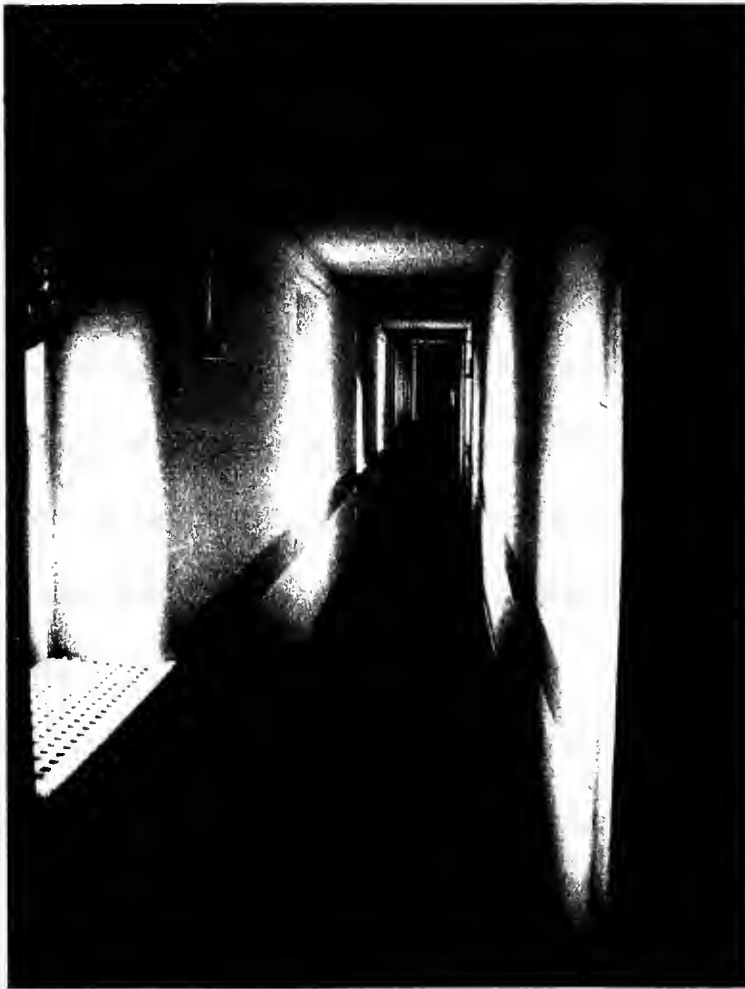
Figure 3.14 The rounded plaster window surrounds can be seen in the John and Penny Christie House in Villanova, designed by Oki in the late 1920's. This aesthetic was intended for the living room windows of the south wall in the MacFarlan House as well as throughout many other rooms. (Courtesy of James B. Garrison).

detail can be visualized in the John and Penny Christis House in Villanova, designed by Okie in the late 1920's as seen in Figure 3.14. The wainscoting is horizontal tongue and groove beaded board which has been mortised, tenoned and pegged into the surrounding vertical stiles (Fig. 3.15c) and rests on the beaded baseboard (Fig. 3.15a). The chair rail rests upon the beaded board wainscoting, extends in front of the windows to create the front of the window sills, and where the sill are not located, the chair rail is notched to receive the plaster walls (Fig. 3.15a). The living room chair rail is the most elaborately designed throughout the house. The vertical corner boards at each end of the walls and the flat cornice at the top of the wall are beaded and are also notched to receive and support the plaster walls and ceiling (Figs. 3.15f-3.15i). These details are characteristic of Okie and utilized widely in his designs. Okie designed all of his millwork to join flawlessly. One will rarely find two pieces of wood butted to one another, but typically notched, pegged, mortised and tenoned or joined in another fashion to each other, often beaded where the two separate pieces meet. The east elevation of the living room is composed of similar details to those of the south elevation with horizontal wainscoting and plaster above.

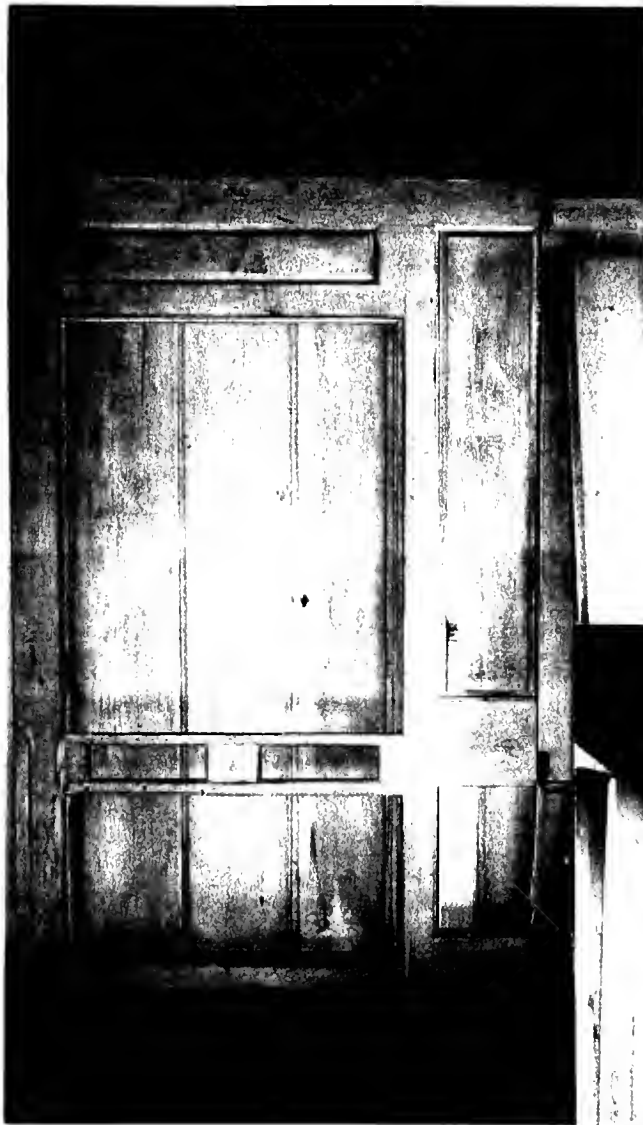
Figure 3.21a This cabinet was designed for the area where the two cabinet doors now exist. The design incorporates two drawers and two sets of cabinets, one above and one below; this was never installed.

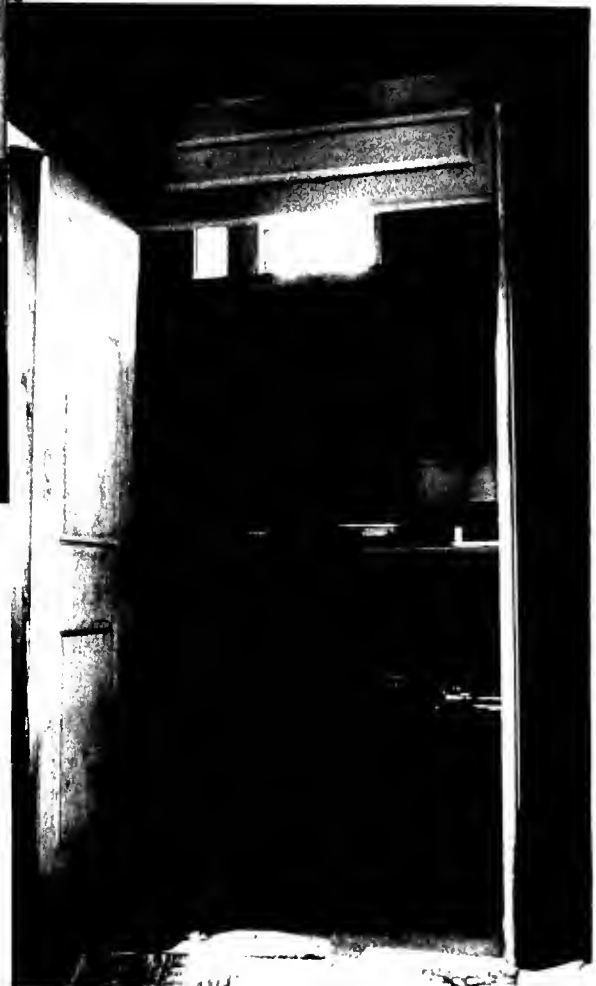
Figure 3.21b This photograph is of the cabinet to the left of the dining room fireplace. A window remains from when this corner was designed as a small staircase to the second floor.

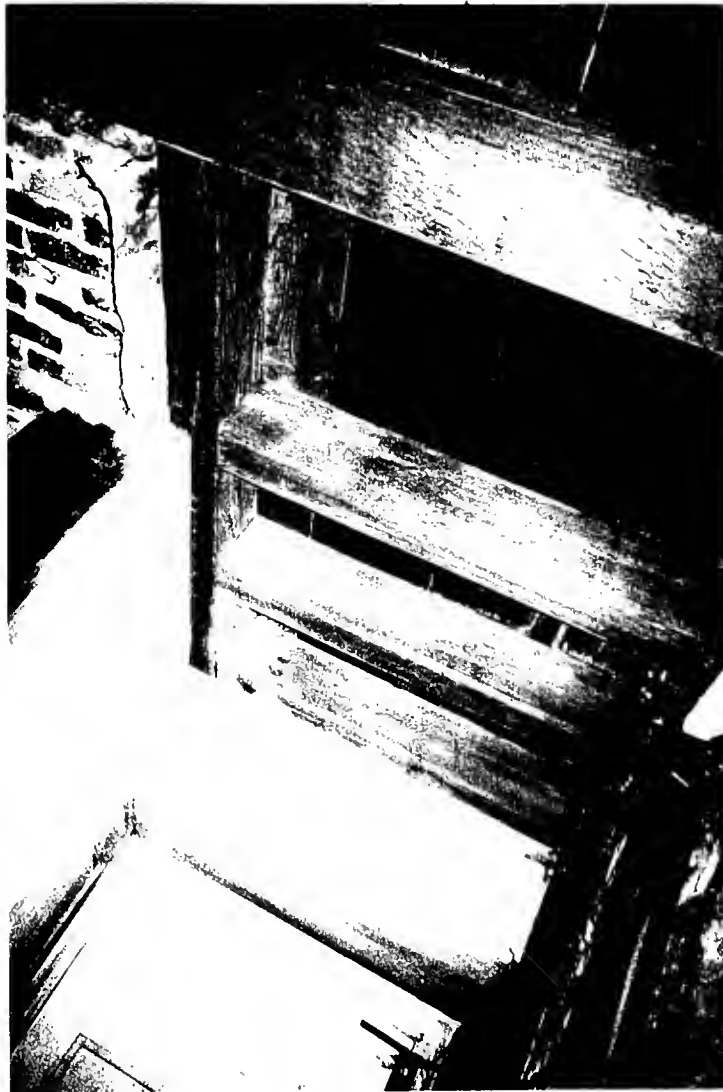
Figure 3.21c This photograph shows the flat panel above the door to the kitchen in the dining room. The current owner believes there was an oversight by not installing a raised panel in this location. Because this area was designed and redesigned several times (last by Charles), it seems possible that this is the case. No other location in the house has this type of situation without a raised panel above a door. There is ample room (more than above many doors), and this flat panel abuts the paneling of the fireplace wall. Perhaps because the panels of the fireplace wall would not align with one over the door, it was not added.
